**Long-Term Surveillance Plan
for the
DOE Bluewater (UMTRCA Title II) Disposal Site
Near Grants, New Mexico**

July 1997

Prepared for
U.S. Department of Energy
Grand Junction Office
Grand Junction, Colorado

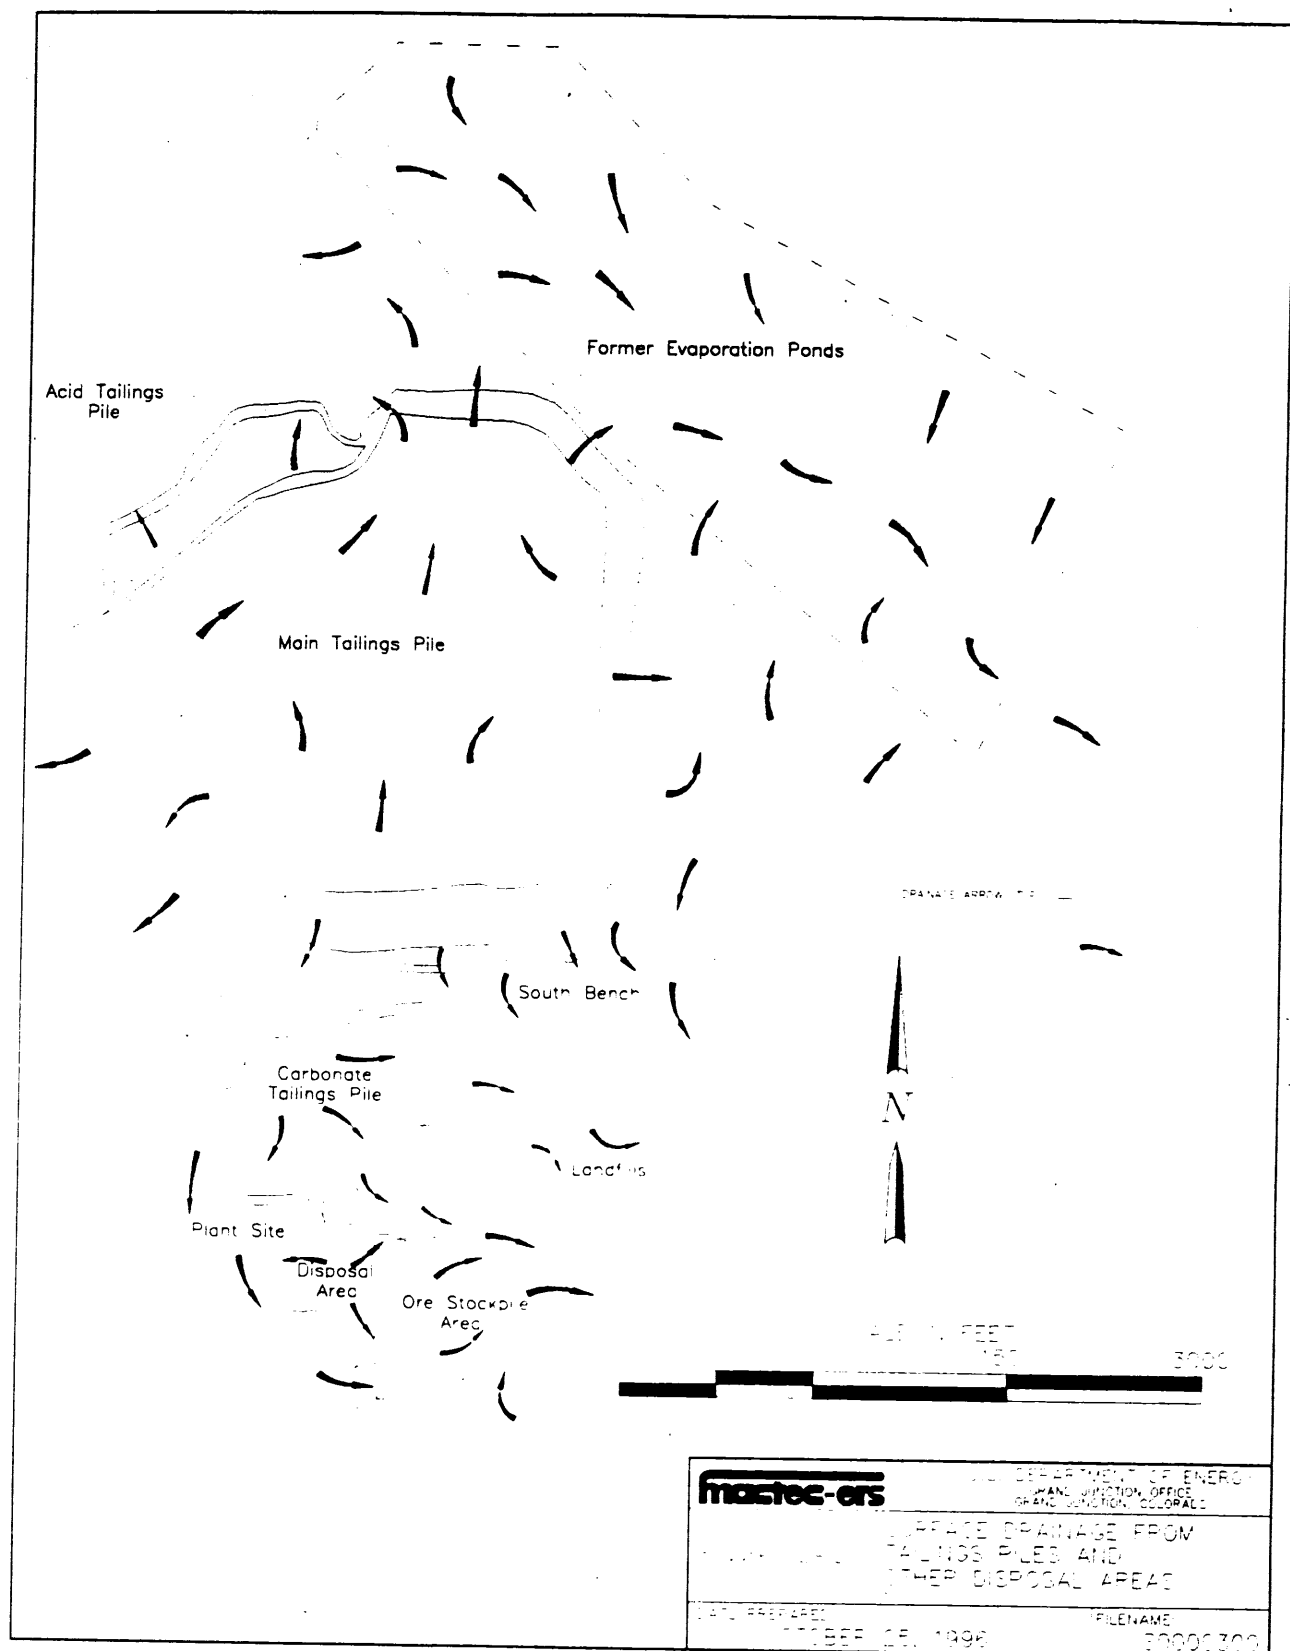
Figure 2-3. Surface Drainage from Tailings Piles and Other Disposal Areas

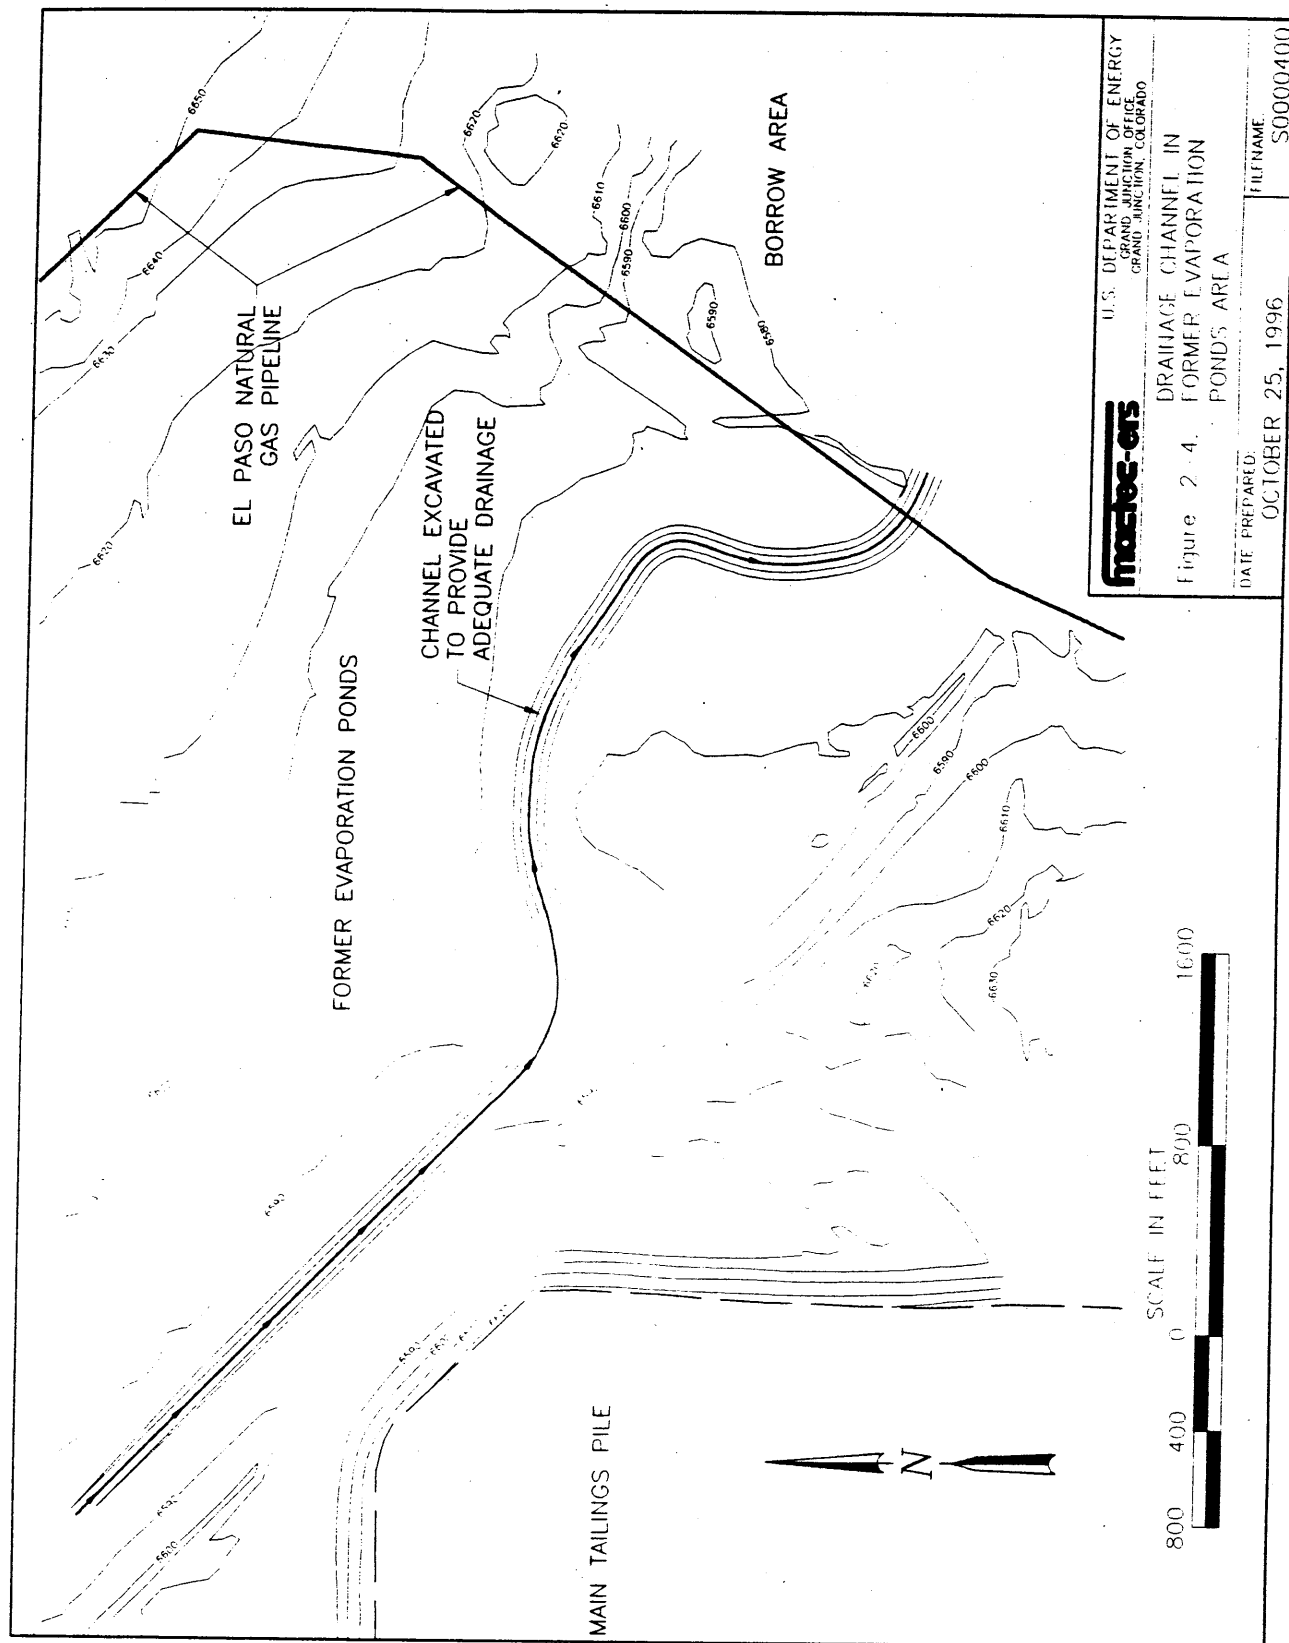
Figure 2-4. Drainage Channel in Former Evaporation Ponds Area

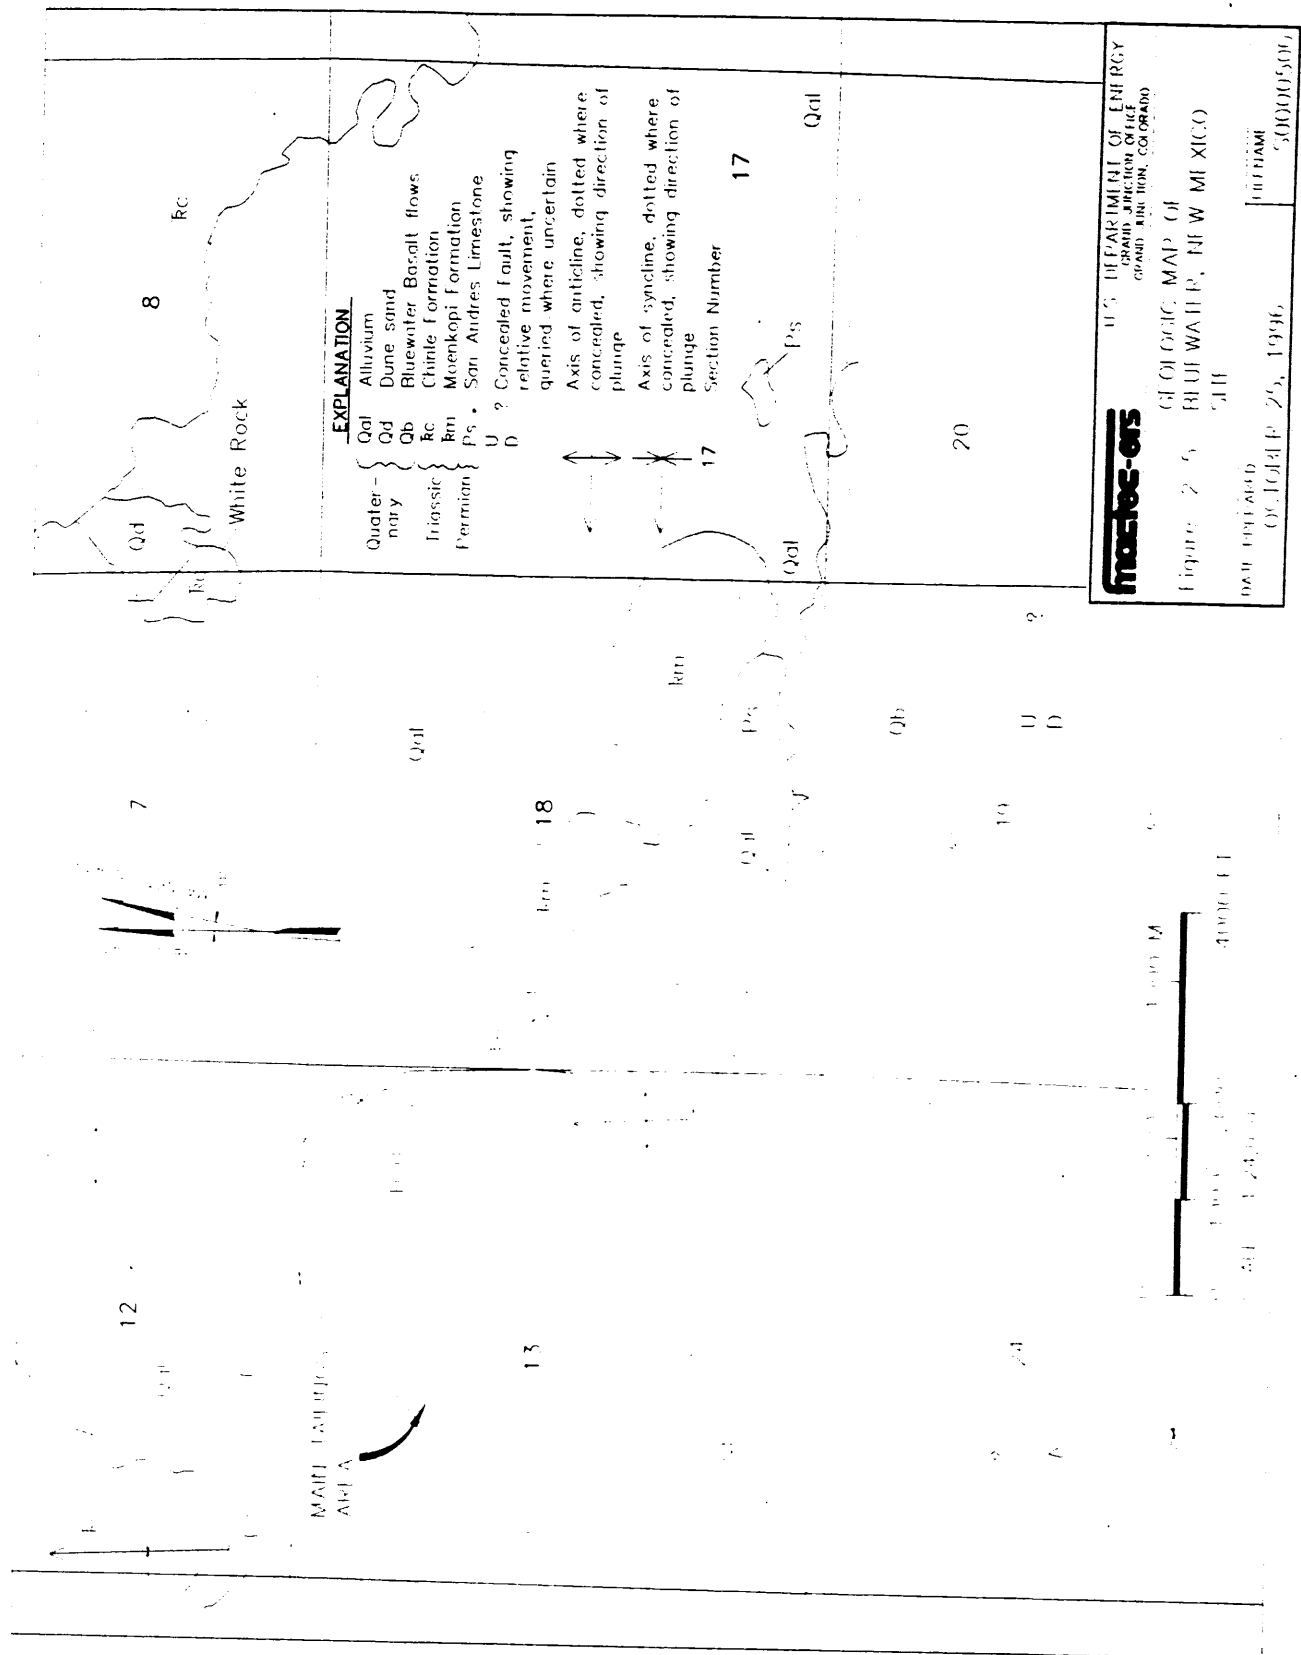
Figure 2-5. Geologic Map of Bluewater, New Mexico, Site

Geology of the Bluewater site is shown in Figure 2-5, which has been compiled and modified from the *Geologic Map of the Bluewater Quadrangle, Valencia and McKinley Counties, New Mexico* (Thaden and Ostling 1967) and from the geologic map, Plate 1, in *Geology and Ground-Water Resources of the Grants-Bluewater Area, Valencia County, New Mexico* (Gordon 1961). The following discussion of

geologic conditions at the site is summarized mainly from the section on "Geology and Geoseismicity" in Volume II of *Licensing Documentation* prepared by Dames and Moore (ARCO 1981).

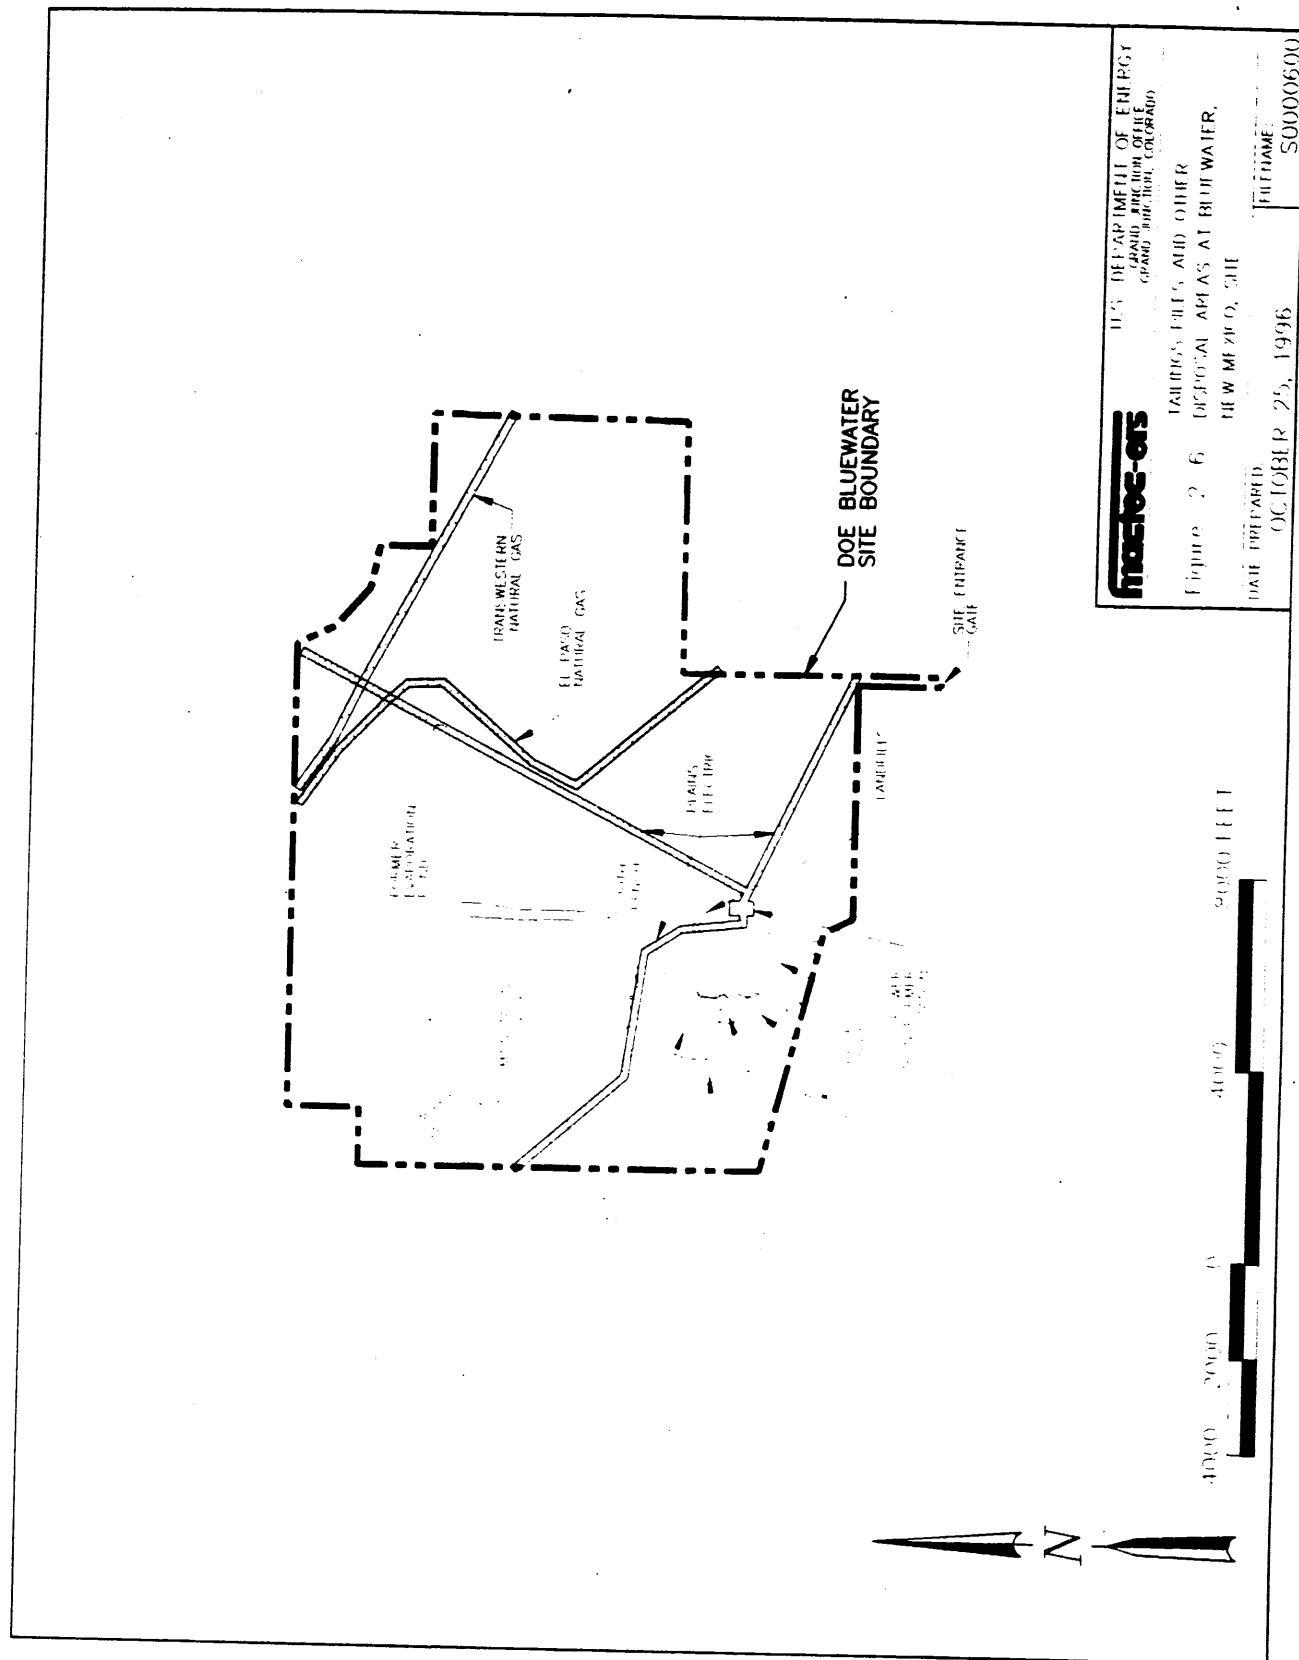
Figure 2-6. Tailings Piles and Other Disposal Areas at Bluewater, New Mexico, Site

The other disposal areas are shown in Figure 2–6, and more detailed maps of these areas are in the Completion Report (ARCO 1996a). The plant site area surface was smoothed to cover foundations and fill sumps, covered by an average thickness of 15 in. (38 cm) of compacted engineered fill, and overlain by 8 in. (20 cm) of topsoil, which was seeded with native grasses.

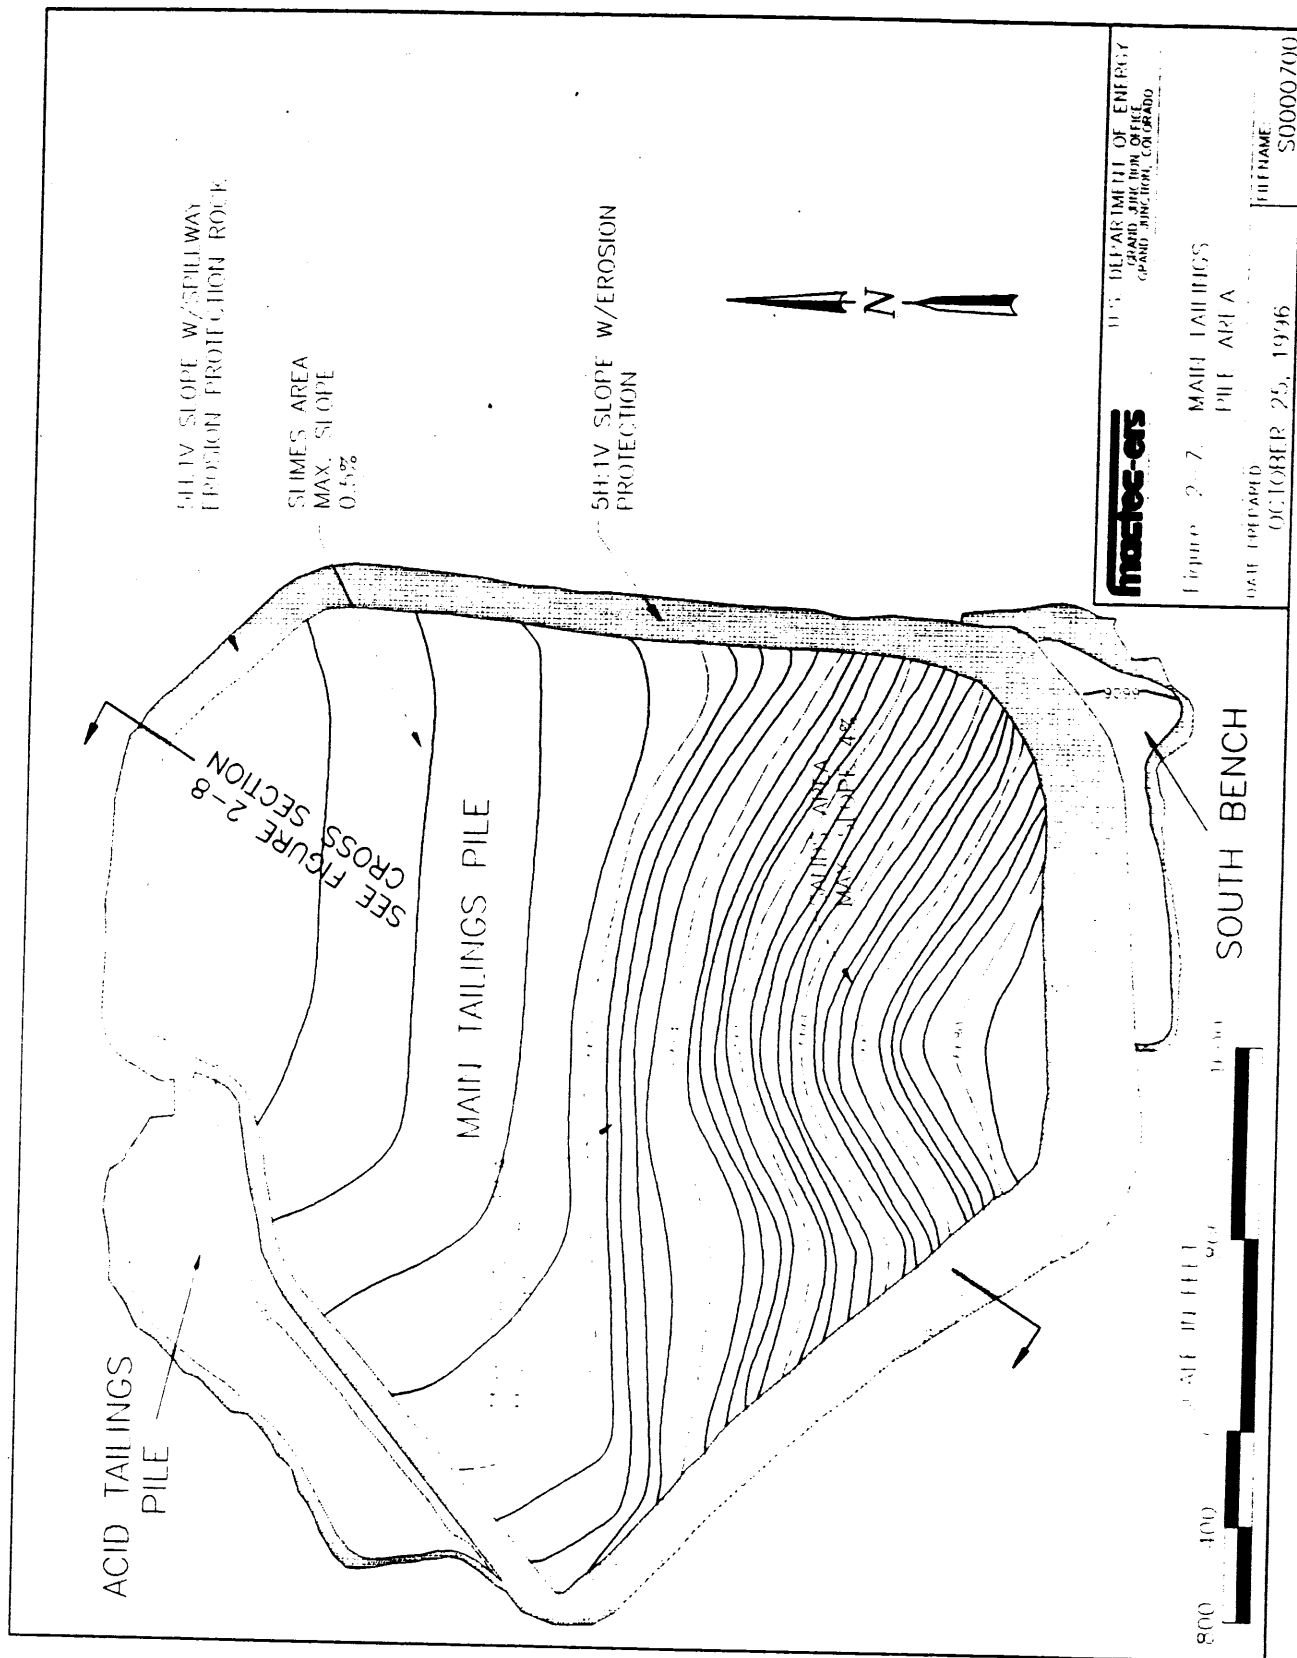
Figure 2-7. Main Tailings Pile Area

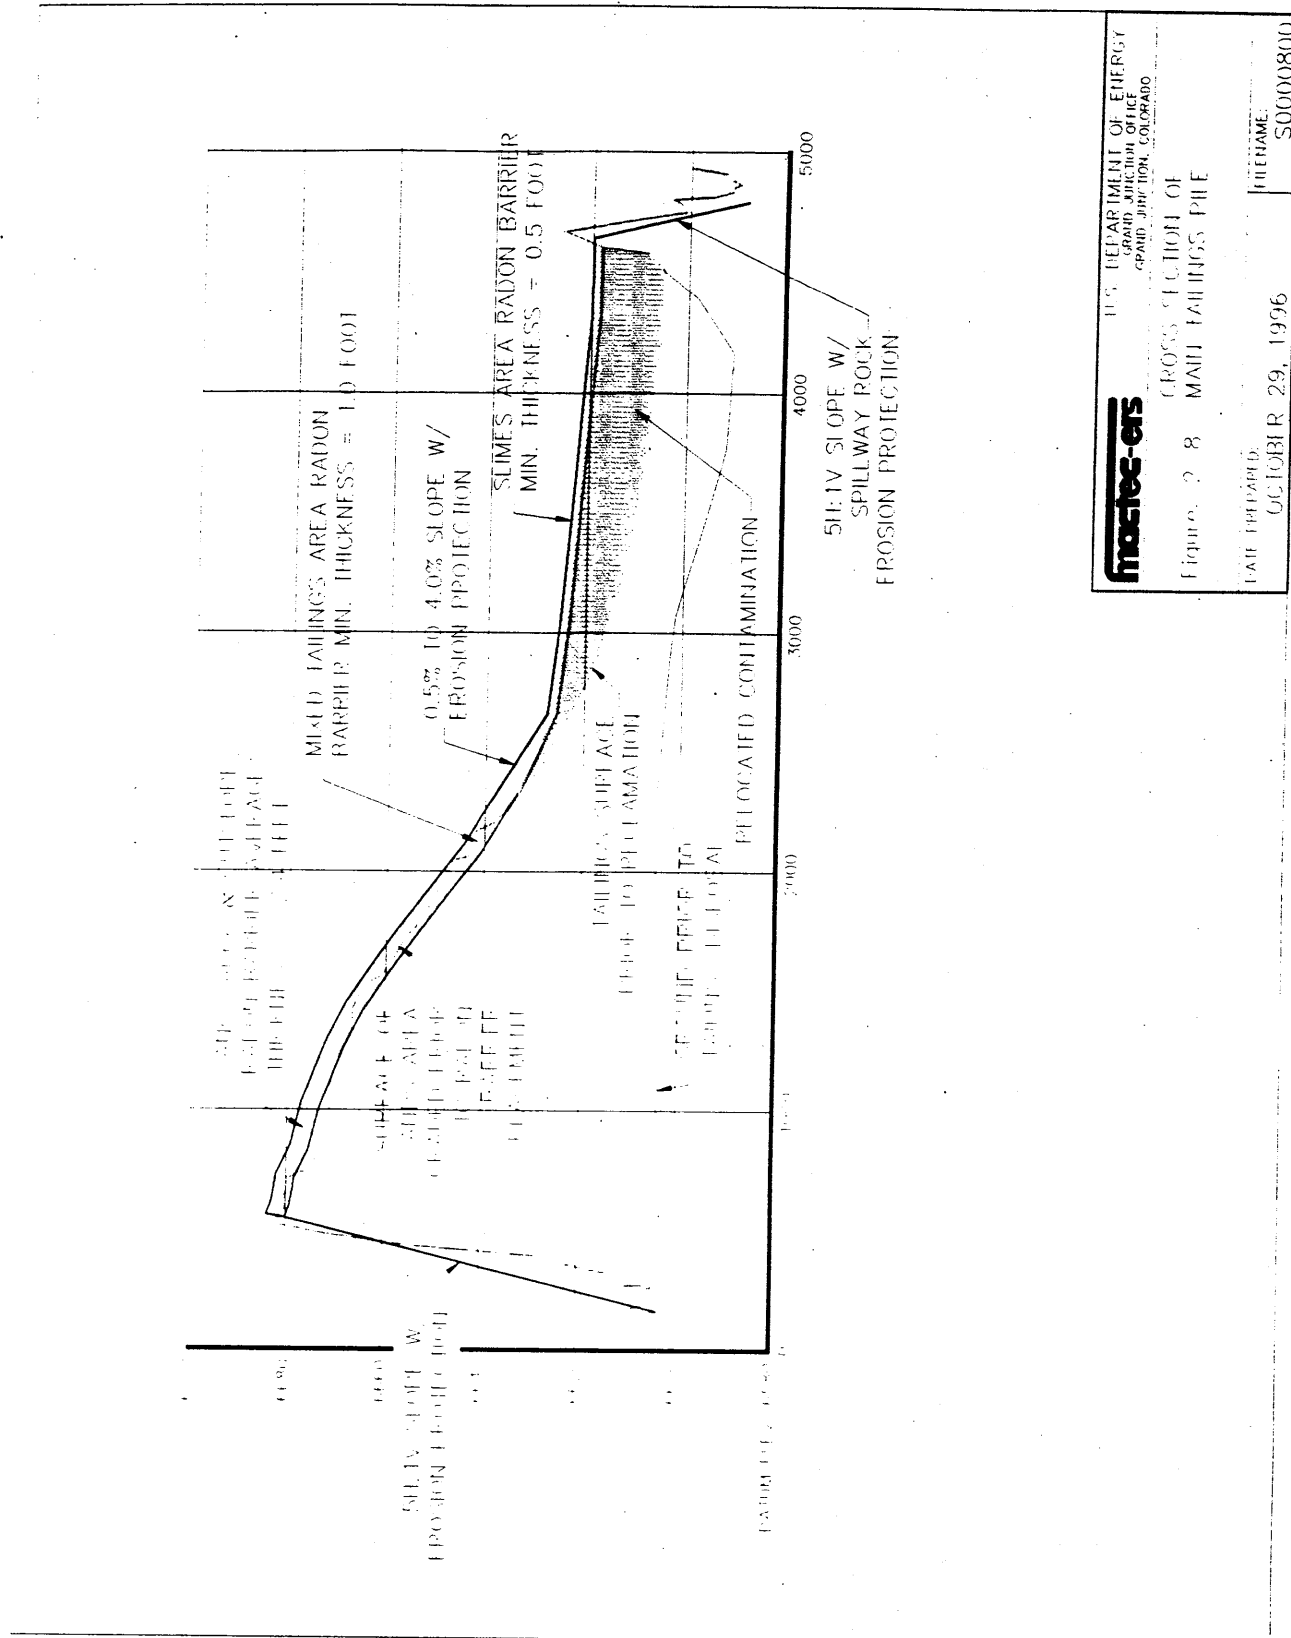
Figure 2-8. Cross Section of Main Tailings Pile

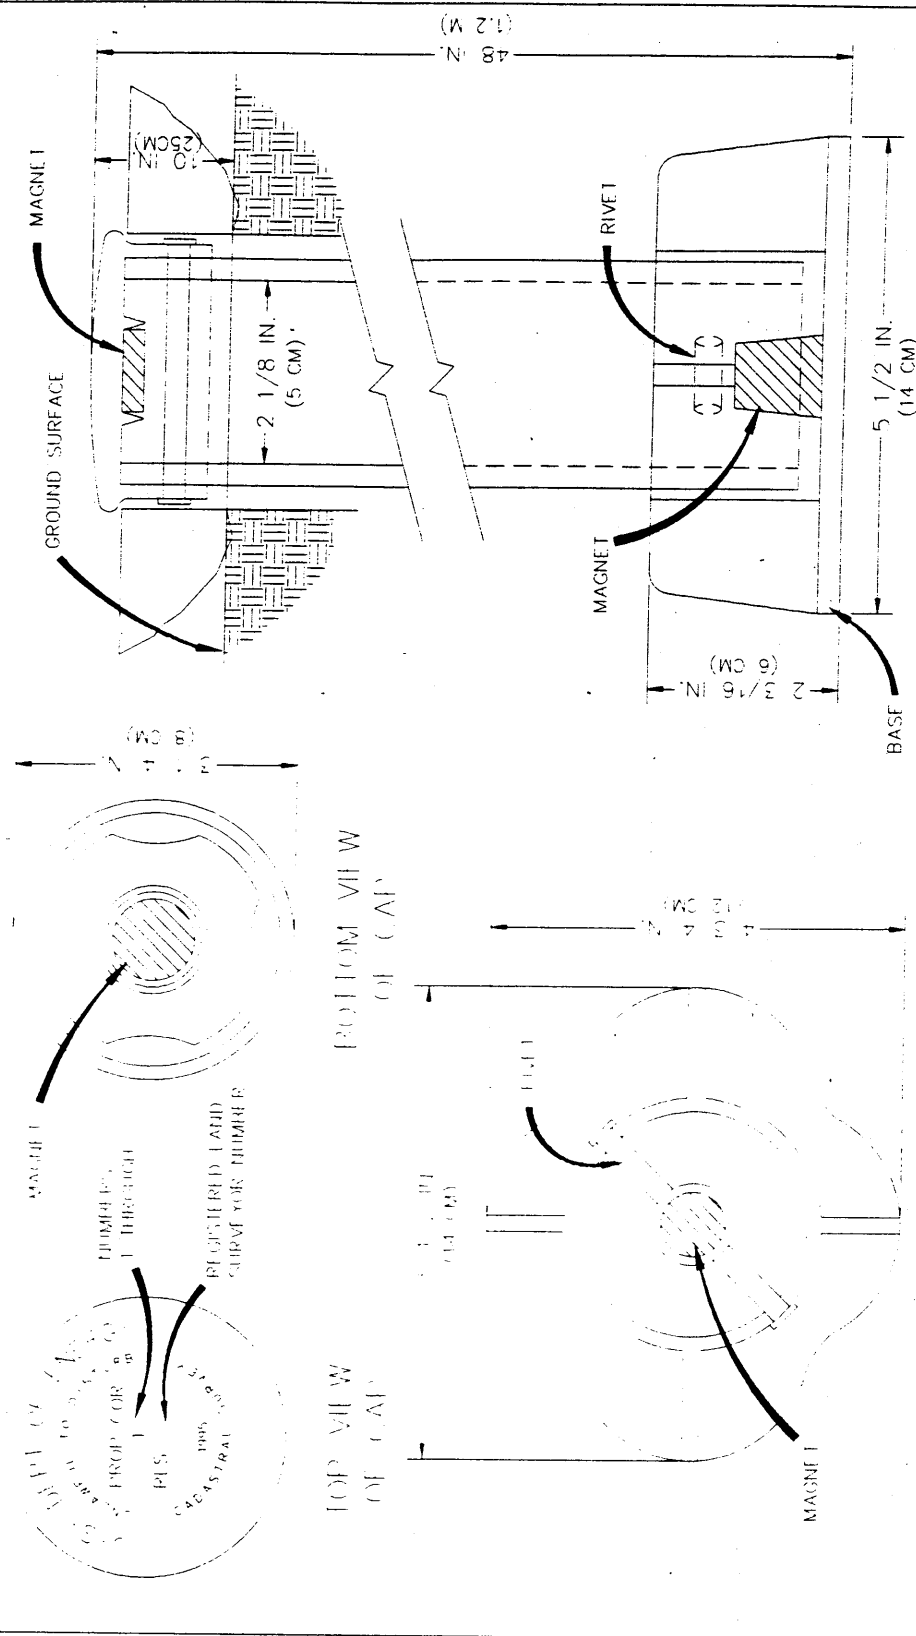
Figure 2-11. Boundary Monument at Bluewater, New Mexico, Site

Bernsten Federal aluminum survey monuments, Model A-1, were used for the 24 boundary monuments (Figure 2-11). Ceramic magnets are epoxied into the cap and base of each monument and are vertically oriented so that the monument can easily be found if it becomes buried. The monuments are set with the base 38 in. (97 cm) below ground surface and 10 in. (25 cm) above ground surface (Figure 2-11).

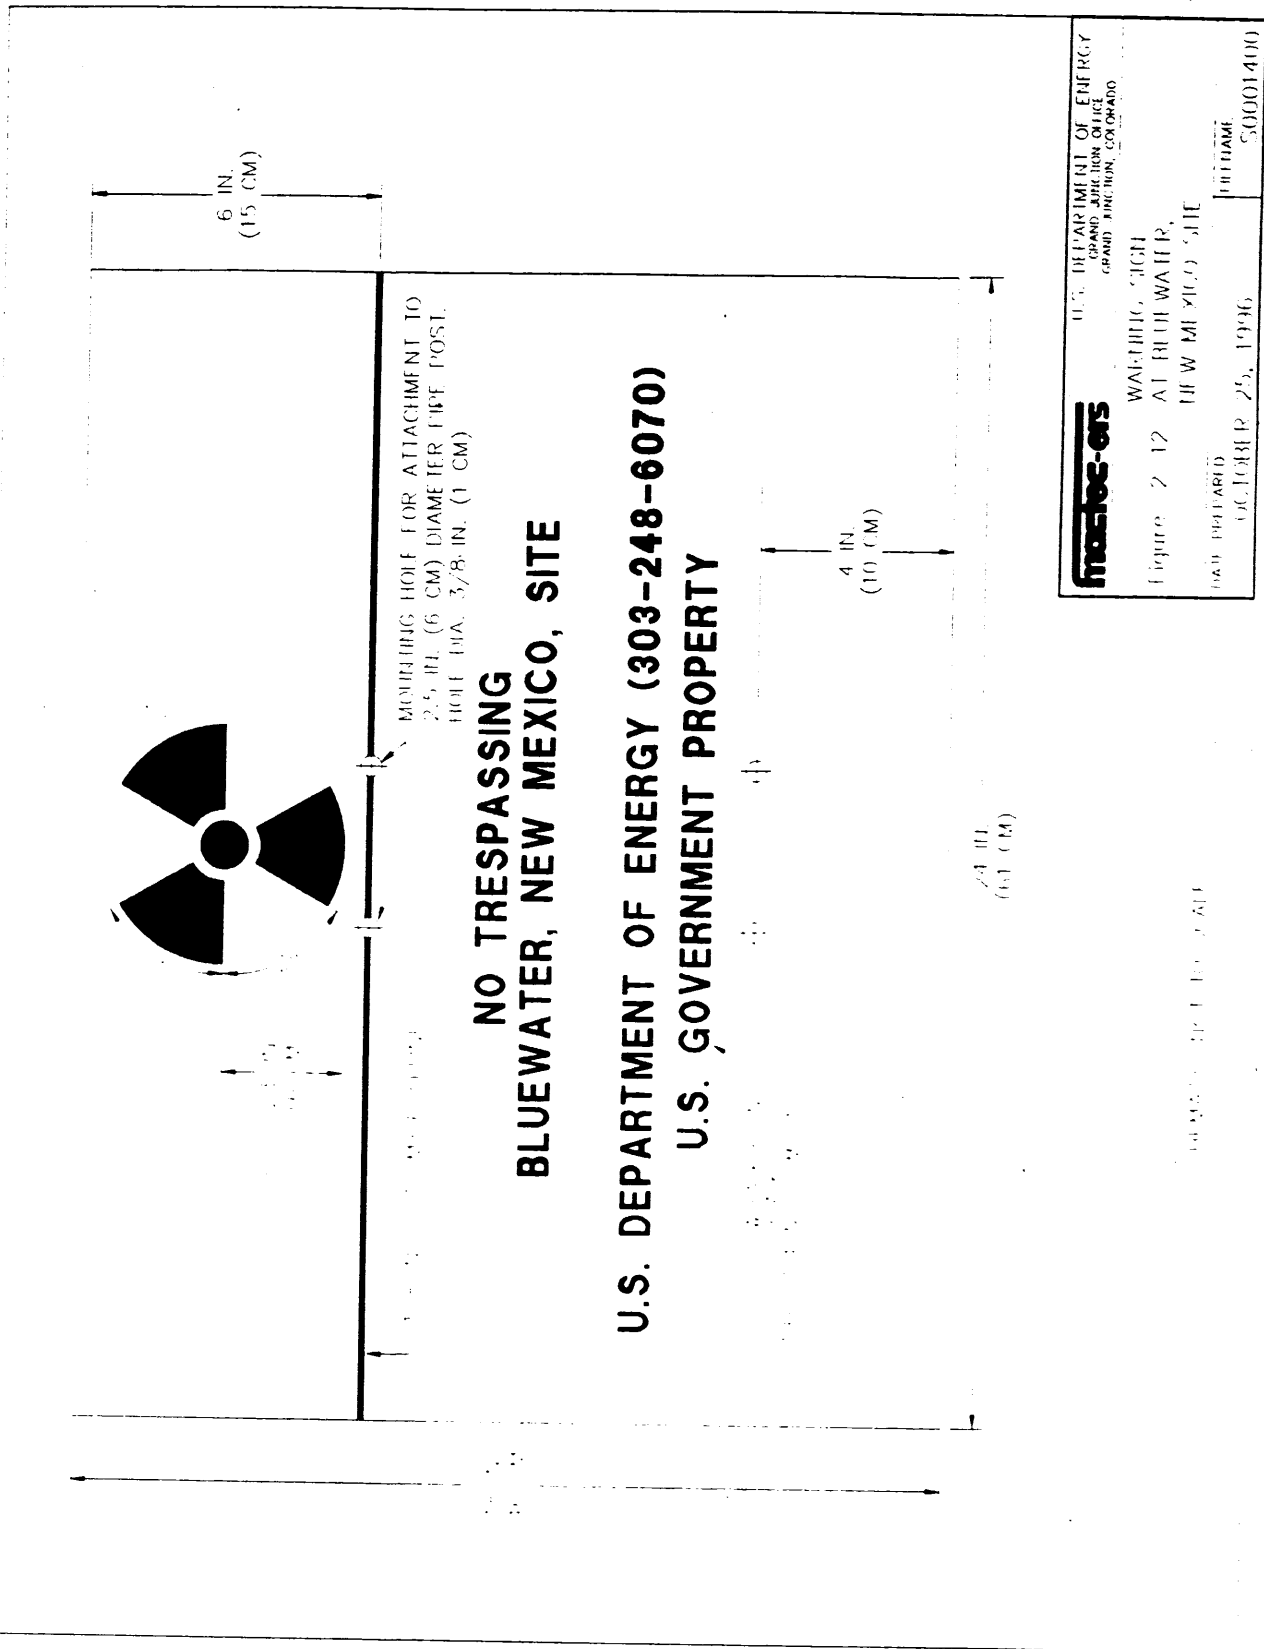
Figure 2-12. Warning Sign at Bluewater, New Mexico, Site

Warning signs are posted at various places around the site property: at the entrance gate, other vehicle access gates, and around the tailings piles and other disposal areas. These warning signs inform the public of the name, function, and ownership of the site (Section 2.6). The signs are attached at a height of about 5 ft (1.5 m) above ground to 2.5-inch (in.) (5.5 centimeters [cm]) diameter pipe (posts) set in concrete. Sign posts are placed approximately 5 ft (1.5 m) inside the fence when set along the site perimeter. Warning signs are similarly placed on posts around the main tailings area, the carbonate tailings area, and other disposal areas. These signs are placed no more than 500 ft (152 m) apart and about 100 ft (31 m)

from the edge of each radioactive material disposal area. These warning signs provide sufficient warning to persons approaching the areas of buried radioactive material. Human intrusion and vandalism are expected to be minor because of the remoteness of the site, sparse population of the area, and land use (mainly cattle grazing) of surrounding land. Additional security is considered unnecessary.

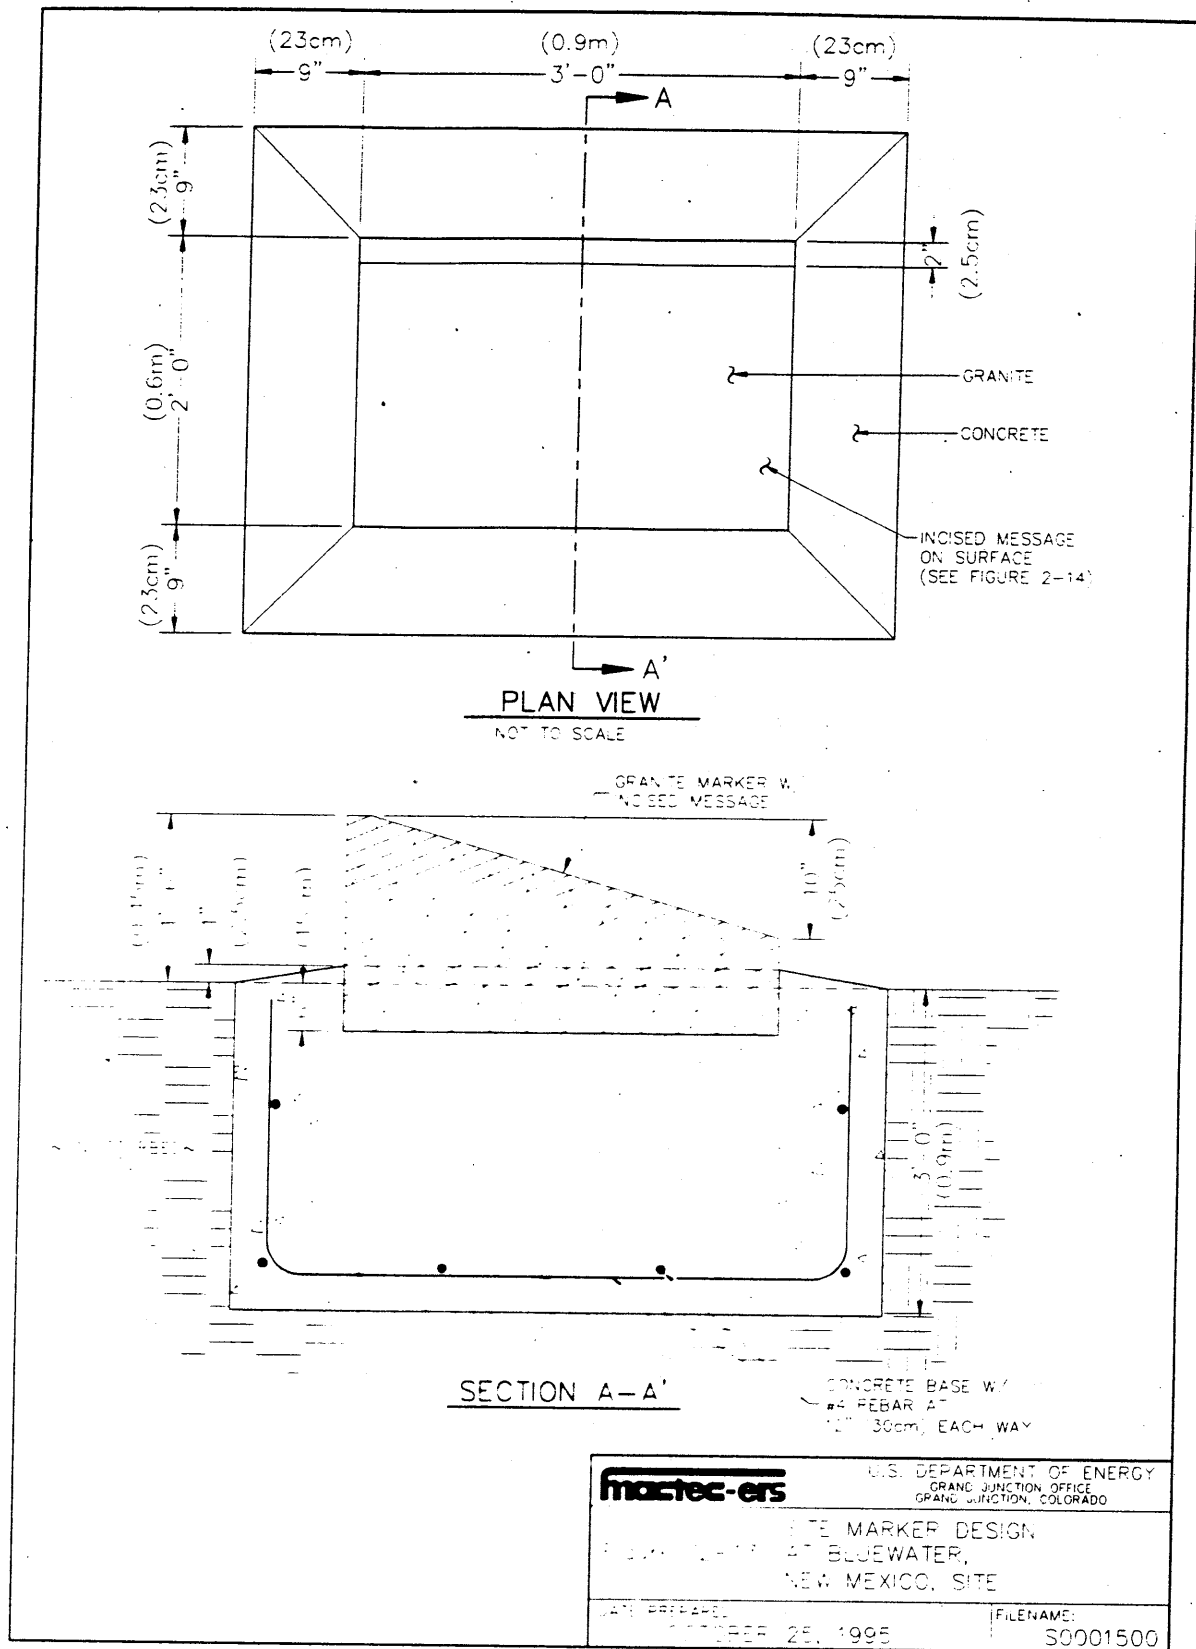
Figure 2-13. Site Marker Design at Bluewater, New Mexico, Site

One unpolished granite site marker with the dimensions shown in Figure 2-13 has been installed at the Bluewater site. Site marker SMK-1 is set on the ground surface in the level area between the main tailings pile and the carbonate tailings pile (Plate 1).

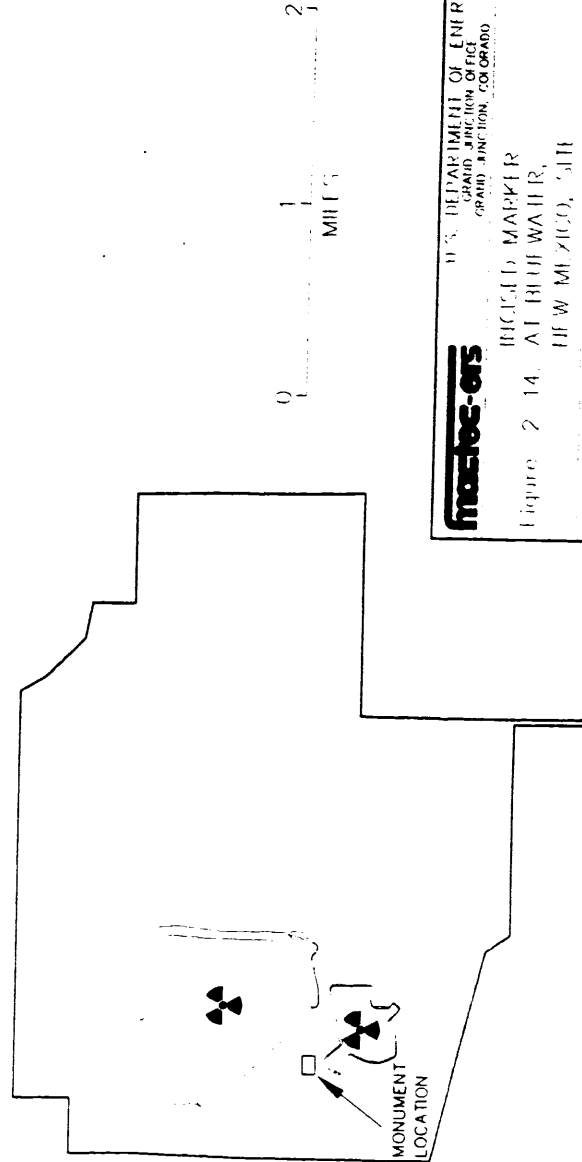
Figure 2-14. inciseo Marker at Bluewater, New Mexico, Site

The inscription on the site marker identifies the general locations of the tailings piles within the site property, the date of closure, the tonnage of tailings, and the curies of radioactivity of radium-226. The international symbol for radiation is also inscribed in the marker at the position of each tailings disposal area (Figure 2-14).
